Manhole Inspection Summary

Manhole # S4100_025MH

Insp Date: **2/21/07 1:59 PM**

Location Address: **2126 SHERWOOD AVE**

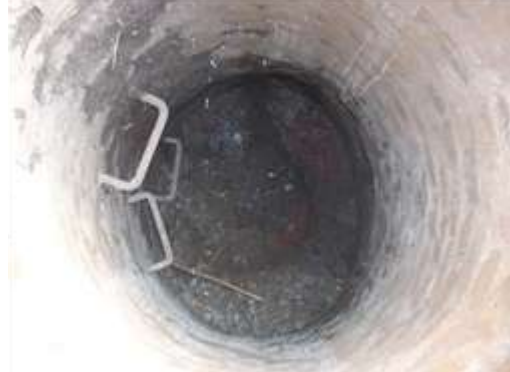
Top View

Channel debris.

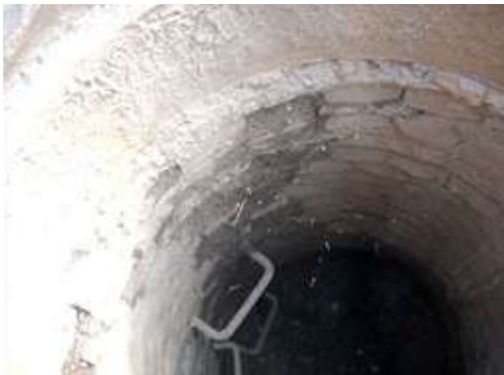
Defect

☒ **Leaks**

Condition: ☐ Sound ☐ Cracked ☐ Root Intrusion ☐ Loose Brick ☒ **Deteriorated**

Infiltration: ☐ None ☒ **Joint** ☐ Cracks ☐ Mortar ☐ Roots ☒ **Wall**

Frame leaks. Adjustment deterioration and infiltration. Corbel and Barrel infiltration.

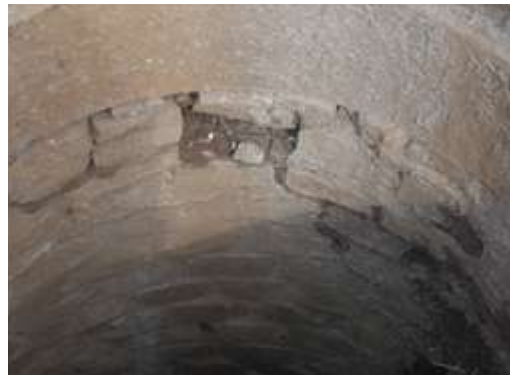
Defect

Frame leaks. Adjustment deterioration and infiltration. Corbel infiltration.

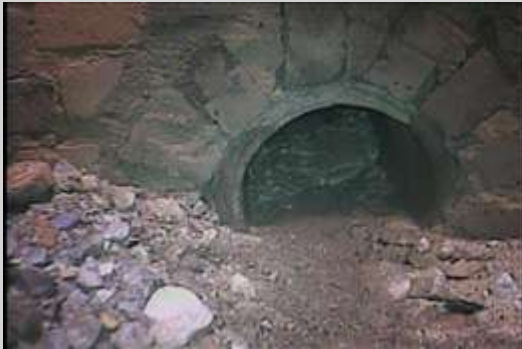
8 in. Circular Gravity Sewer
Pipe Out @ 12 O'Clock

Deposits: ☐ None ☒ **Mud** ☐ Sludge ☒ **Debris** ☐ Grease

Silt Depth: **3** (in.) Deposits Extent: **Heavy**

Infiltration: **Evidence** Pipe Seal Cond: **Unknown**
